VUOTSO SCHOOL

Energy audit

Pesonen Otto, Pernu Juho & Moilanen Kari

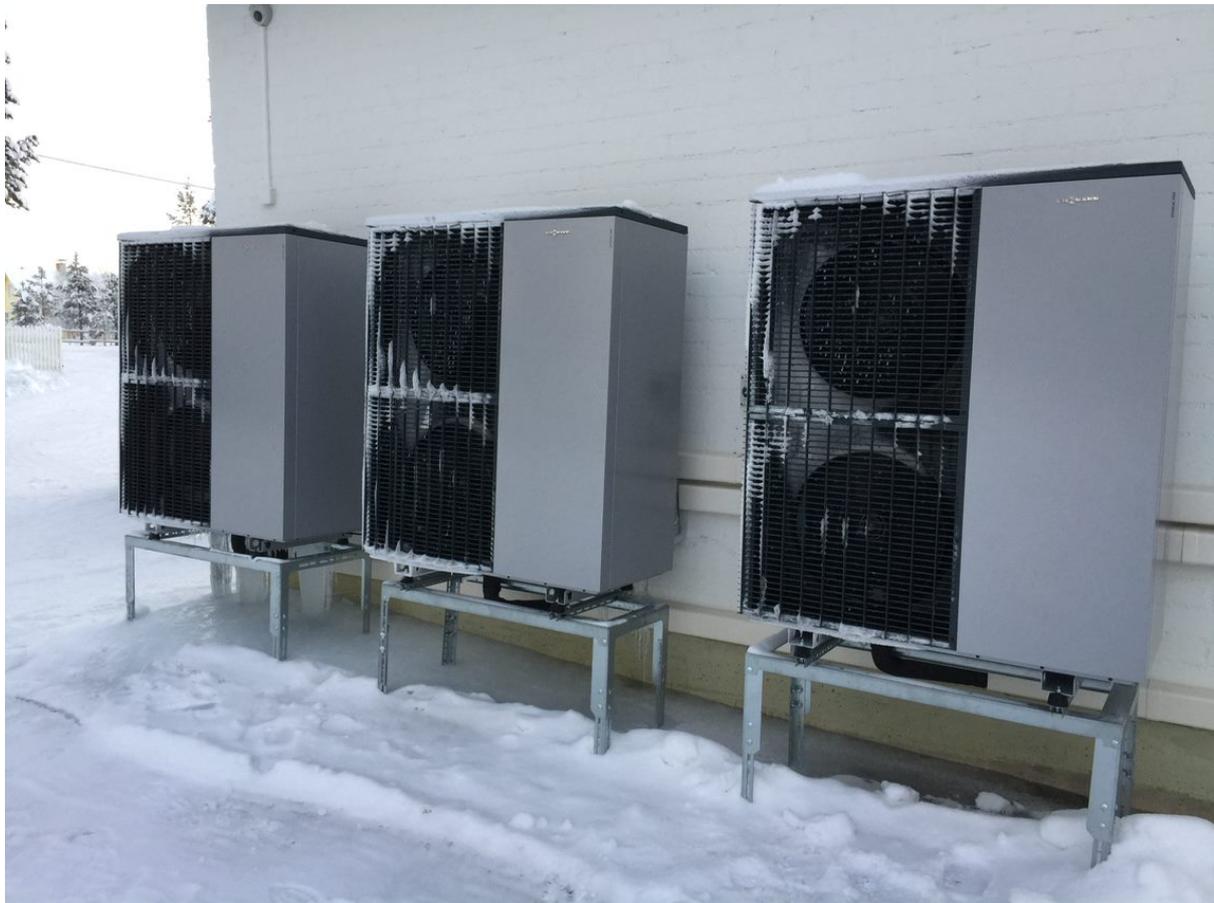
The energy output of the heat pump system installed in summer 2018 has not been taken into account in the calculations. The savings potential brought by the air-to-water heat pump is not yet fully reflected in the consumption figures for 2018, and there have been problems with the operation of

the system according to the property manager. The operation of the heat pump and consumption figures should be monitored more closely during the spring months, and if there are no obvious savings, pump supplier / service organization should be contacted.

Figure 1: Outdoor units of the heat pumps

- Inspection of system operation / maintenance
- Guidance for how to use the system
- Lowering the flow temperature of heating water, if possible, it would reduce the use of the oil burner

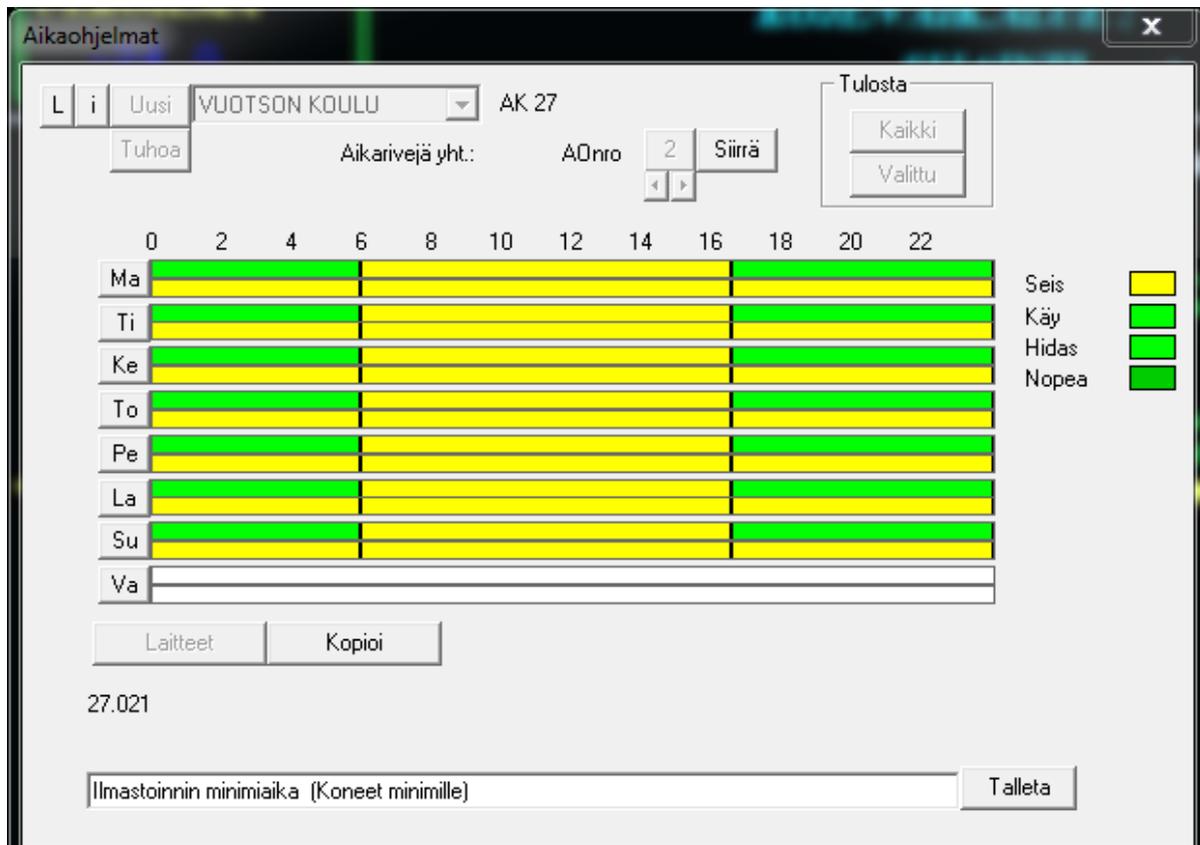
Scheduled run times of ventilation machine for school building are implemented by following time programs. Green colour indicates time when ventilation runs at minimum power.

Figure 9: At night time the ventilation is at minimum power

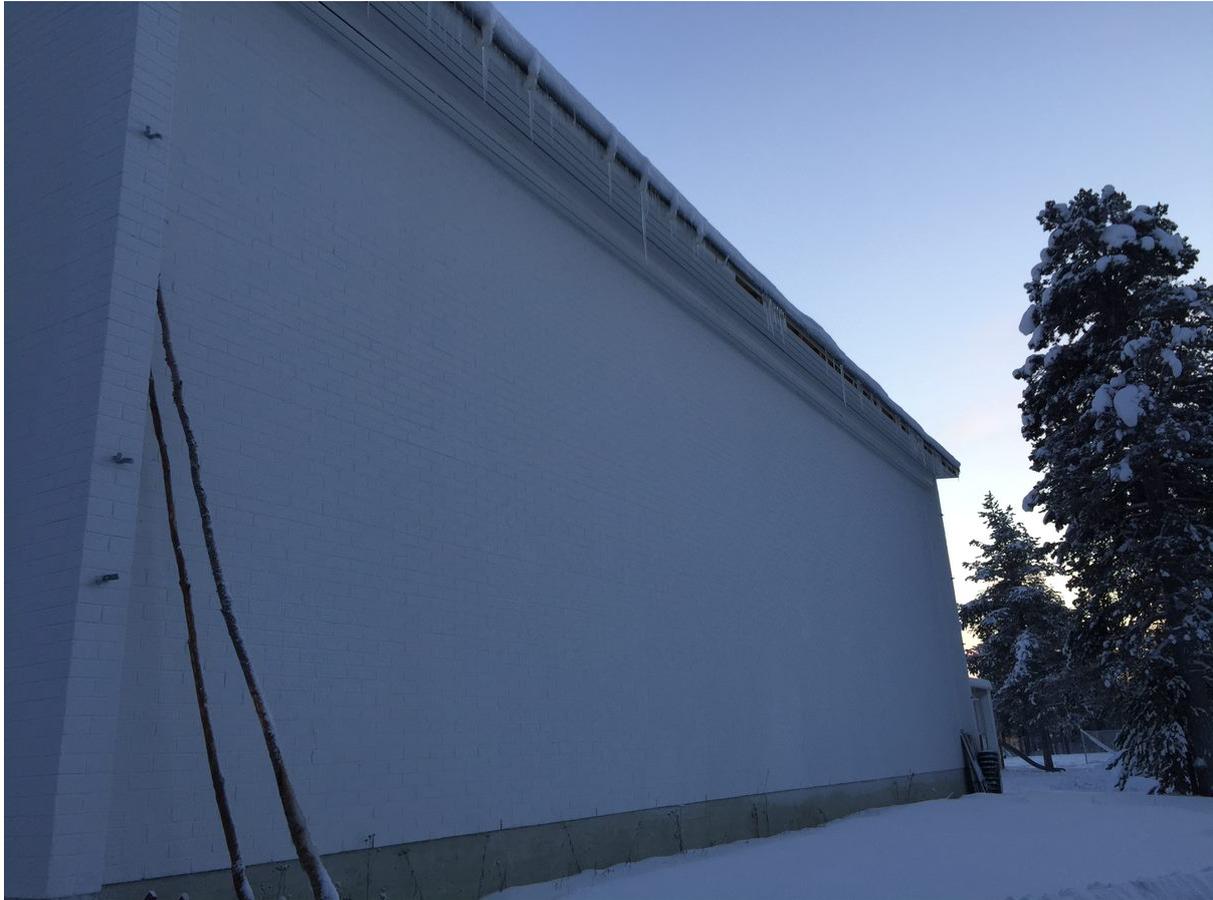
The level of insulation of the roof of the gym could not be determined, but according to the observations, there are heat leaks in the structure, or the insulation level is insufficient. Icicles during the winter temperatures indicates heat leaks or insufficient insulation levels.

Figure 12: Icicles hanging from the eaves

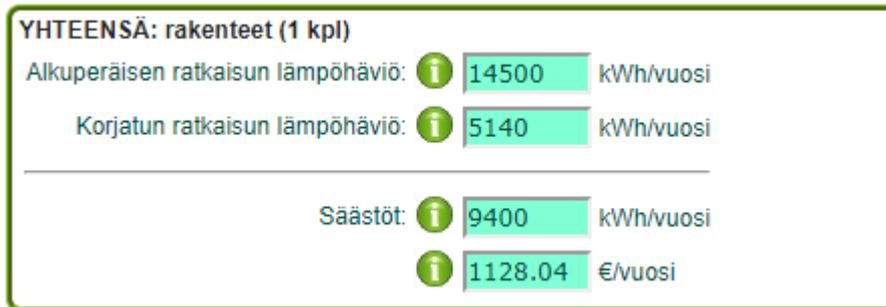
The attic floor insulating level was found to be defective. The additional insulation area is about 400 m². The thickness of the insulation to be added is about 300mm.

$400\text{m}^2 * 0.3\text{m} = 120\text{m}^3$. The additional wool cube price blown is approx. 40-45 € / m³ incl. VAT 24%
The investment price will be about 4800 - 5400 €. inc VAT. 24%. The payback period for the investment is 4-5 years.

Figure 14: Calculation of saving potential for additional insulation

Further insulation possibilities for the other attic floor structures should also be explored.
