ADMINISTRATION  
BUILDING  
LPSHP

Energy audit

Pernu Juho, Pesonen Otto & Rintala Mikko

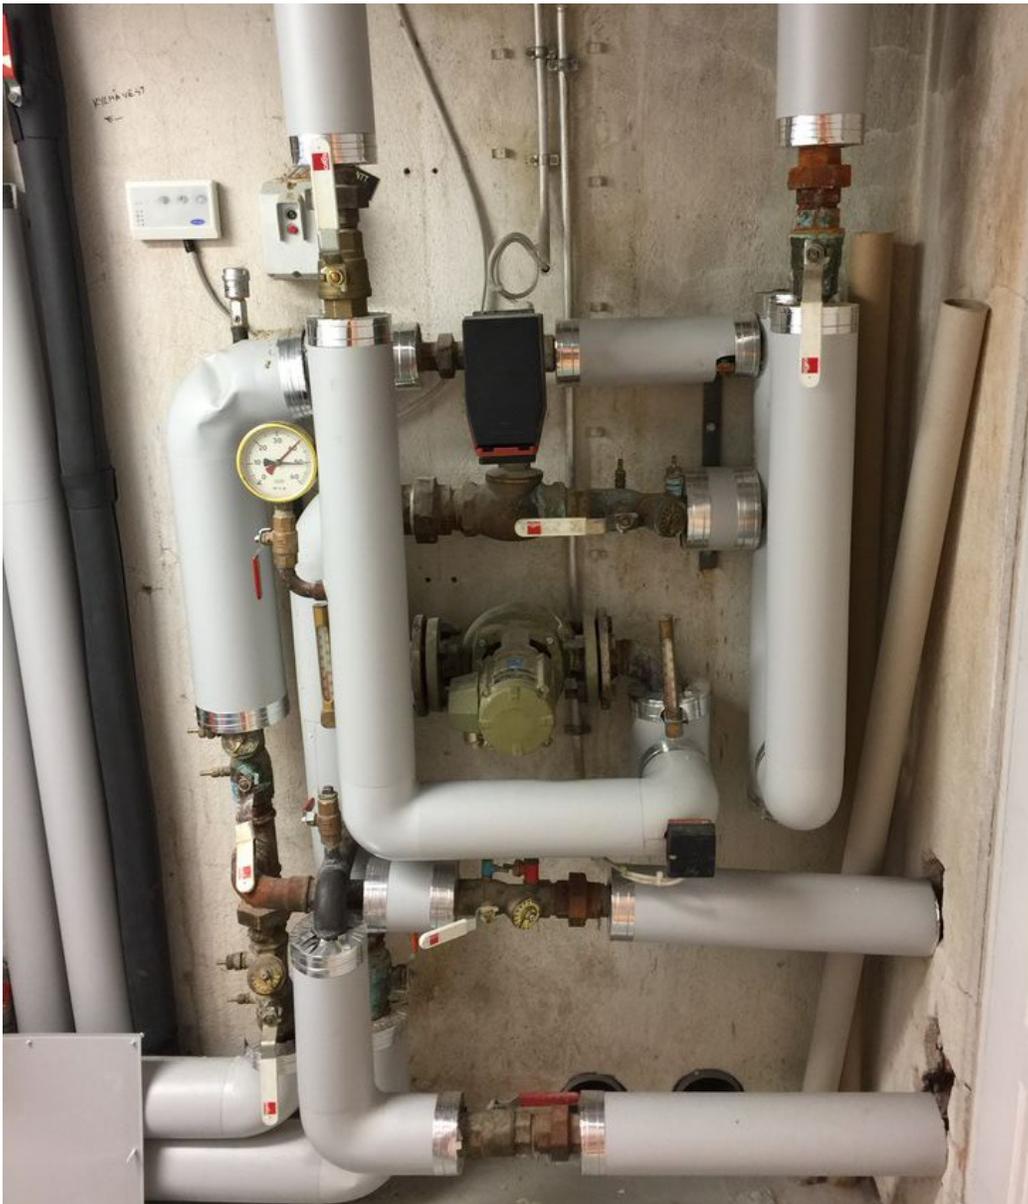
Picture 1: Sub distribution center

Heating energy and usage water is brought to the administration building from areal heating network via hospital building's heat exchanger. Building does not have a sub measurement for heating energy.

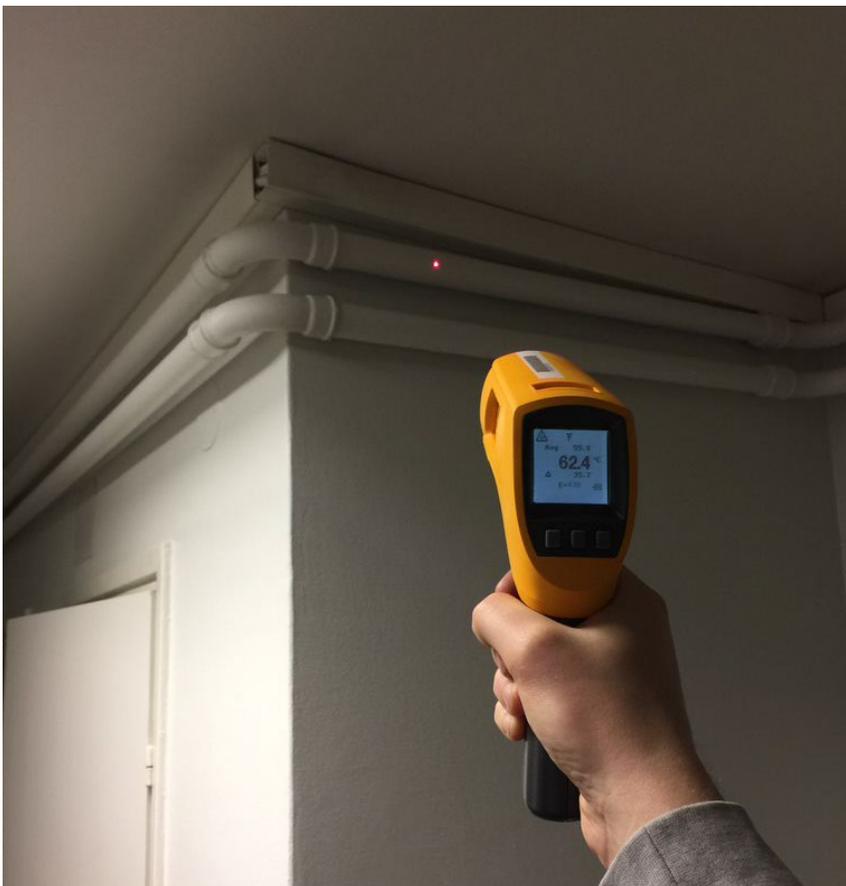
Picture 2: Non-insulated heat pipe in corridor 103.

Radiators' temperatures were measured during the audit. Highest measured temperatures were 59 °C, and temperature of heated, flowing water was 62 °C. Heat pipe runs through structures and office spaces mostly without insulation, which causes high room temperatures in some rooms.

Building's passages and duct require sealing, since cold air flowing through them affects negatively on energy efficiency and comfort. Possibility of adding insulation to attic floor should be investigated. Non-insulated heat pipes and ventilation ducts should be insulated.

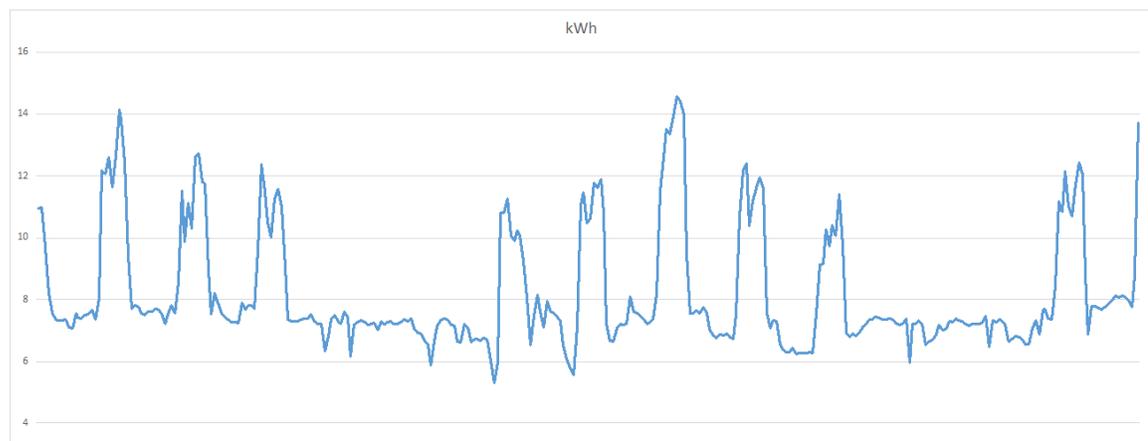
Picture 3: Hour consumption data of electricity in 15. - 29.1.2019.

Hour consumption of administration building represents typical office building. Consumption peaks are, not so surprisingly during office hours, and base load created by ventilation, pumps and electric heaters, is quite stable during nights and weekends.

Base consumption 7.5 kWh

Peak consumption 14.5 kWh (Both measured on Wednesdays)

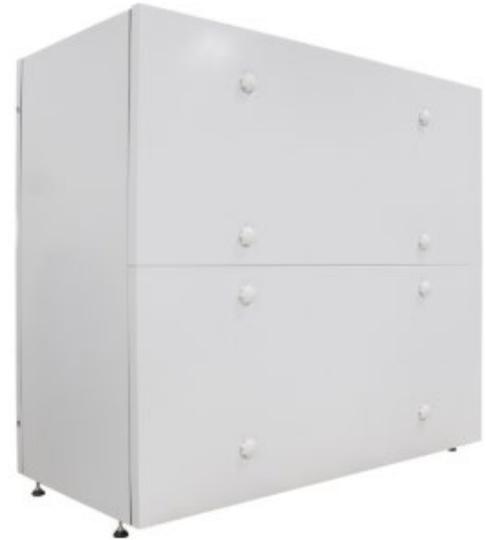
### Deekax talteri DIVK-C220

Temperature of second floor's supply air was noticeably high, and exhaust air temperature was quite low. Traditionally exhaust air temperature matches room temperature, which implies that some of the air ducts are exposed to elements on their way to the ventilation machine. Insulation of ducts is recommended.

- Supply fan: 520 W
- Exhaust fan: 520 W
- Pre-heat resistor: 1000 W
- Post-heating resistor: 1000 W
- Maximum volume 220 l/s
- Annual electricity consumption 19 MWh/a
- Energy saving potential 11 MWh/a
- Bought energy 8 MWh/a

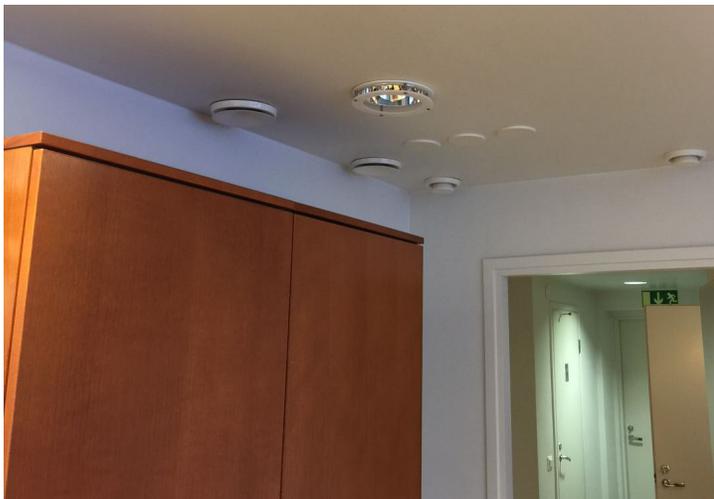
Picture 4: Supply air flows directly towards extract valve.

Ventilation of eastern wing is carried out by HRV-systems located above attic floor. Ventilation machine serving 1<sup>st</sup> floor has supply air flow of 75 l/s, set to 23 °C. Ventilation needs adjustment. Some of the terminal devices are located poorly, guiding supply air flow to hit user directly. This causes feeling of draft, and some of the users had implemented DIY solutions to guide airflow away from them.

Most of the air leaks could be eliminated by adjusting supply and exhaust flows to match each other and sealing the passages. It is also worth noting, that terminal devices of ventilation may not be the most suitable for office spaces.

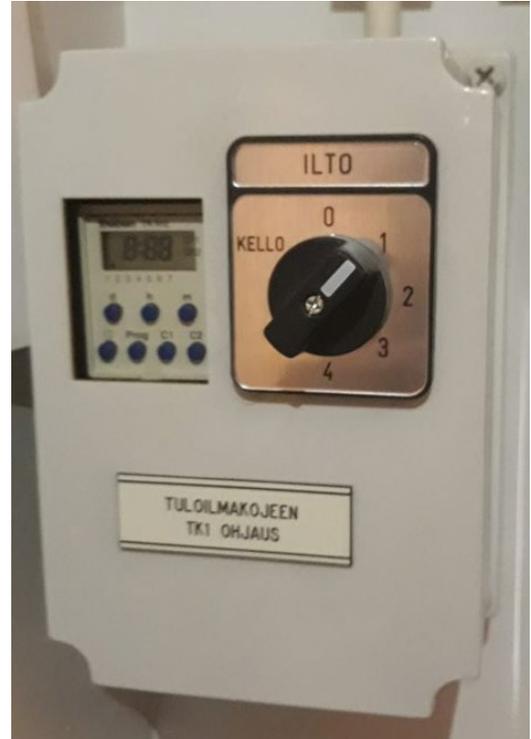
## Ilto 800 405

Meeting room in basement has its own ventilation machine. Air flow volume of machine was massive during audit, 2,5-3 m<sup>3</sup>/s. Air volume is considered excess in relation to the size and use of the spaces.

*For example, heating 2,5 cubic meters in second to 20 degrees warmer requires 60 kW of power from heating resistor.*

Currently the most energy consuming single component is heating radiator of basement ventilation system. Air volumes of the system seem to be massive for spaces with so little use. If it isn't possible to setup HRV system to current ventilation system, the only energy saving measures are to check air volumes and add control switch for users.

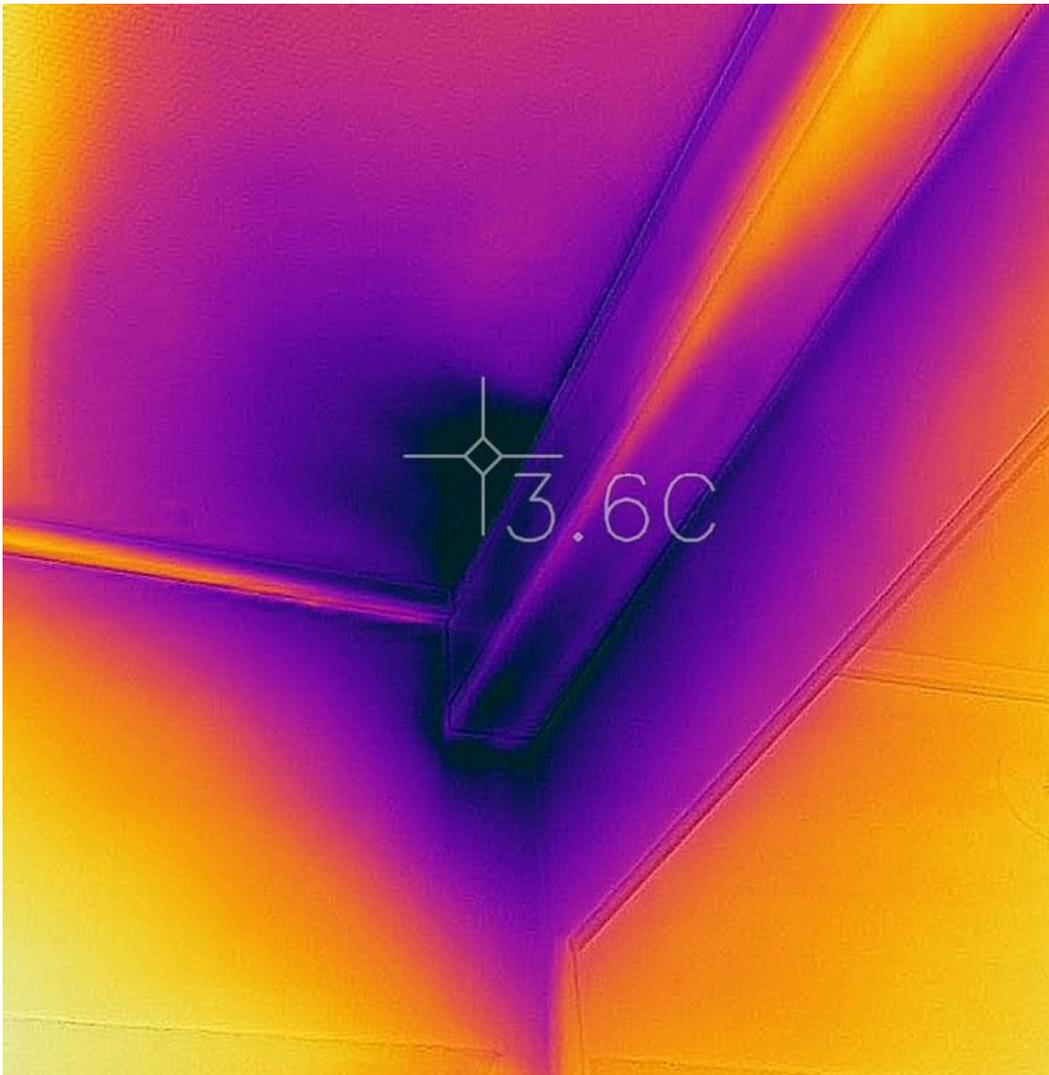
Picture 5: Cable passage.

Thermal imaging (Flir One Pro) and surface temperature measurements were done during the audit. Vacuum in building causes uncontrollable airflow to building via unsealed passages and ducts. These cause very low surface temperatures during winter months.

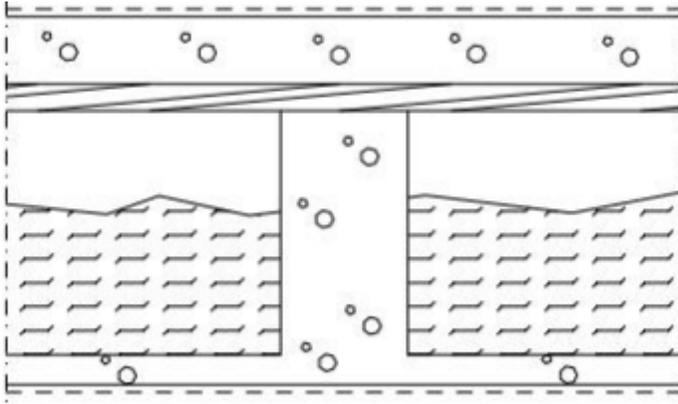
Picture 6: Twin slab structure

Wall structure is typical to era; massive brick structure 1½ bricks thick with 50 – 100mm of insulation inside. Subfloors and attic floor are twin slab structures, 500mm thick. Insulation of twin slab has usually consisted of organic materials, such as wood chip. Windows were in good shape and no leaks were spotted.
